Fire Technology Transfer Note

Number - 19

December 1998

The Bucklands Crossing Fire Burnover

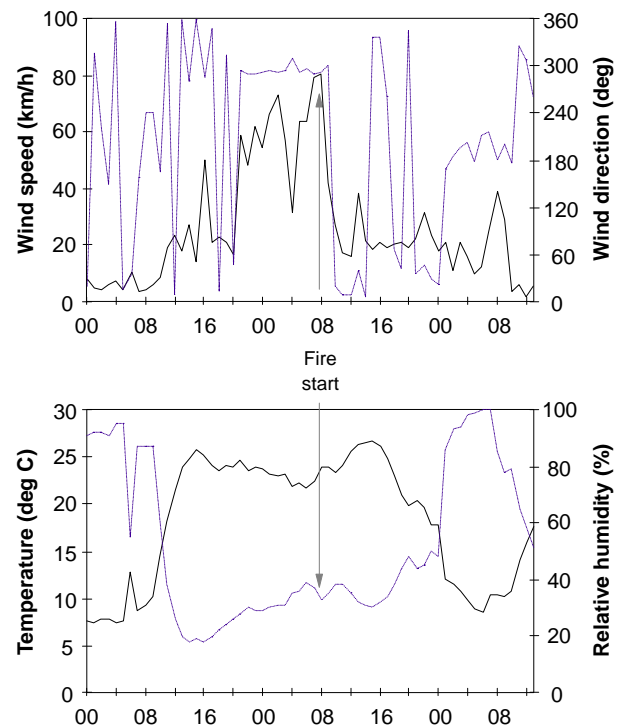
The fire occurred during hot, windy conditions in a period of extended dryness¹. Recorded temperatures on the day of the fire reached 27 °C (Fig. 1), and higher values were reported at the fire site. Gale force nor'westerly winds that exceeded 80 km/h initially restricted aerial suppression operations and, although they dropped off during the day, the erratic strength and direction of the wind contributed to unpredictable fire behaviour.

¹ Weather and FWI System values for midday on March 24 were: temperature 25.5 °C, relative humidity 35%, wind speed 16 km/h, 6 days since >0.6 mm rain, FFMCI 92.0, DMC 41, DC 569, ISI 12.9, BUI 70, and FWI 31.

Figure 1. Hourly weather values before, during and after the initial run of the Bucklands Crossing Fire, using weather data from the Rock and Pillar weather station some 40 km northwest and inland of the fire site.
